# UNITED ENGINEERING CONSULTANTS, INC.

## FIELD OBSERVATION REPORT PERMIT # BLDC-00620-2022

Report No. 14	Page 1 of 2
Project:	Oceans West One Condominium	Inspection For:	Building Repair and WP Project
Day/Date:	Thursday, July 21, 2022	Job No.	20-1153
Location:	1 Oceans West Blvd. DBS, FL 32118	Engineer:	Christopher B. Longman, P.E.
Contractor:	SPEC Contractor Services	Project Foreman:	Alberto
Subcontractor:	None	Inspector:	Christopher B. Longman, P.E.
Weather:	81 Degrees @ 10:22 A.M.	Sunny	Calm winds 20% Chance of Rain
Workforce Total:	13		
Activities:	Painting rails 05/06, Deck coating 01/02 balcony stacks, Concrete repair 01/06 stack

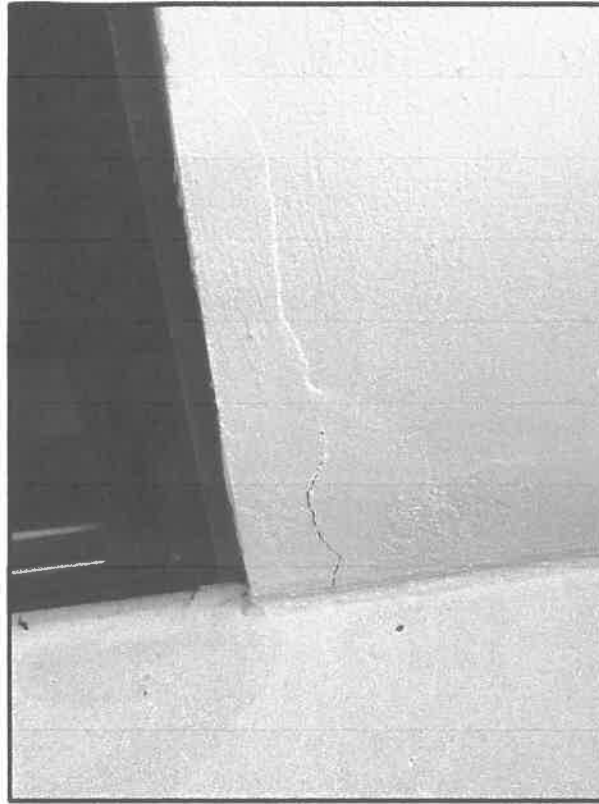
The Contractor has added a swing stage to the 03/04 balcony stack. UEC inspected the 03/04 stack balconies and A/C closets to identify locations of concrete and stucco damage. Areas with damage were marked with orange paint for excavation and repair. In general, there was a small amount of damage identified in both the A/C closets and on the balconies. The following A/C units will need to have the unit lifted due to topside spalling: 3B3, 4B4, 8B4, 9B3. Slab spalling at the edge was identified in the A/C closets at the following floors: 3<sup>rd</sup>, 6<sup>th</sup>, 7<sup>th</sup>, 10<sup>th</sup> and may need the louvers removed. UEC could not access the A/C closet at the 21<sup>st</sup> floor or the balcony of Unit 21B3 due to the shutters being closed.

Photograph #1: Concrete damage identified at the 03 balcony stack

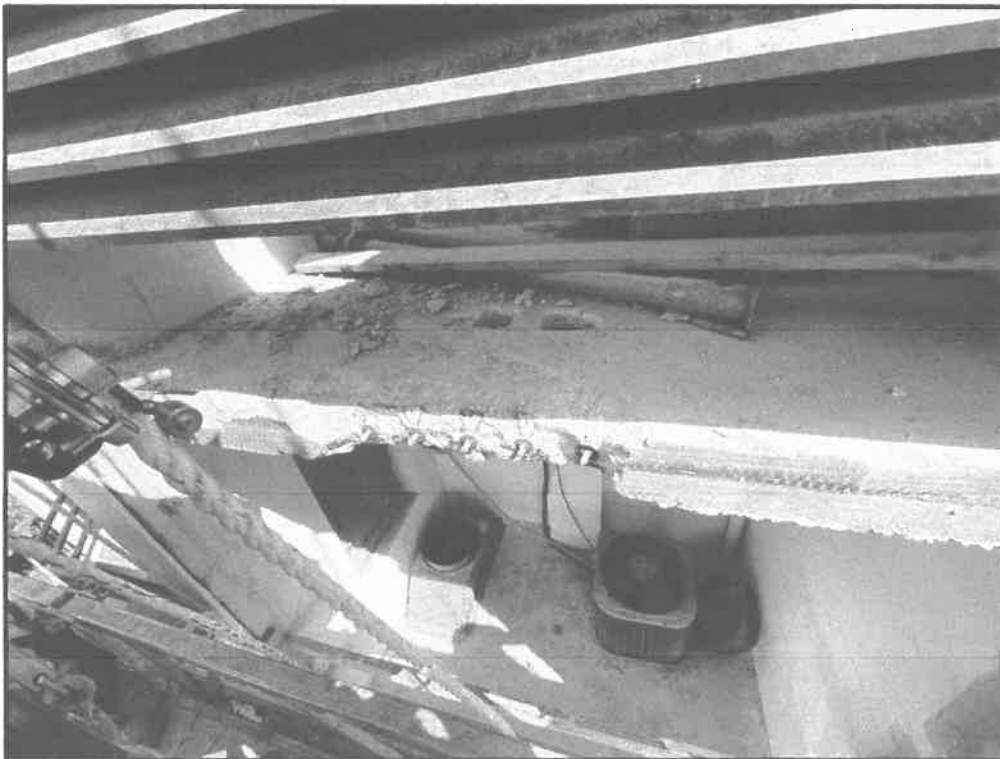
UEC observed the in-progress post tension repairs in the A/C closets between the 06/01 balcony stacks. The following was noted at each floor:

- 9<sup>th</sup> floor – no lockoffs required, repair can be completed with cables in tension.
- 10<sup>th</sup> floor – 2 lockoffs installed but not stressed, repair can be completed with the remaining of the cables in tension
- 11<sup>th</sup> floor – 2 lockoffs installed but not stressed, repair can be completed with the remaining of the cables in tension.
- 12<sup>th</sup> floor – it is possible that 2 lockoffs will be required to complete excavations.
- 14<sup>th</sup> floor – 5 lockoffs installed and stressed, and slab is ready for repair demo.
- 19<sup>th</sup> floor – 5 lockoffs installed and stressed, and slab is ready for repair demo.

Photograph #2: In-progress post tension repairs at the 01/06 balcony stack.
