# UNITED ENGINEERING CONSULTANTS, INC.

## FIELD OBSERVATION REPORT PERMIT # BLDC-00620-2022

Report No. 70	Page 1 of 2
Project:	Oceans West One Condominium	Inspection For:	Building Repair and WP Project
Day/Date:	Friday, April 14, 2023	Job No.	20-1153
Location:	1 Oceans West Blvd. DBS, FL 32118	Engineer:	Christopher B. Longman, P.E.
Contractor:	SPEC Contractor Services	Project Foreman:	Alberto
Subcontractor:	None	Inspector:	Andrew Holland
Weather:	71 Degrees @ 8:40 A.M.	Mostly Sunny	Light Breeze 40% Chance of Rain
Workforce Total:	18		
Activities:	Tower A: Final punchout 02/03 stack and 01 window wall, Concrete repair 03/04 balcony stack, Prepping parking deck ramp walls, Post tension repair work at column line 9A

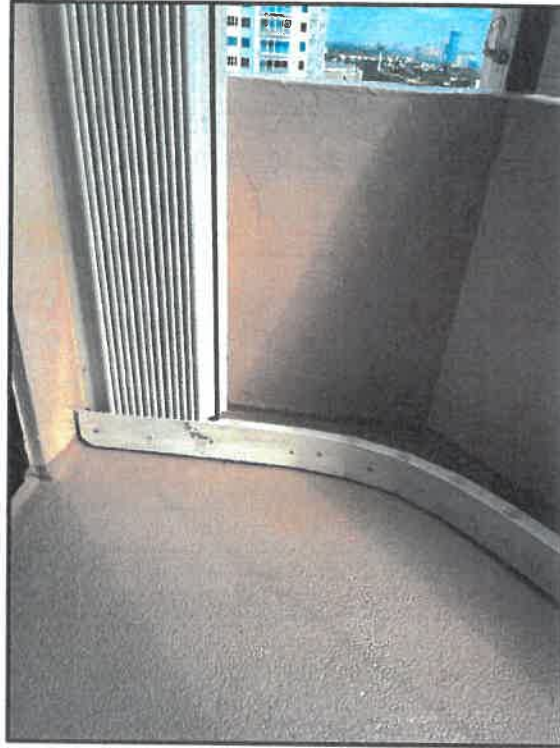
**Photograph #1: Excess deck coating observed on the shutter track at the balcony of Unit 1702**

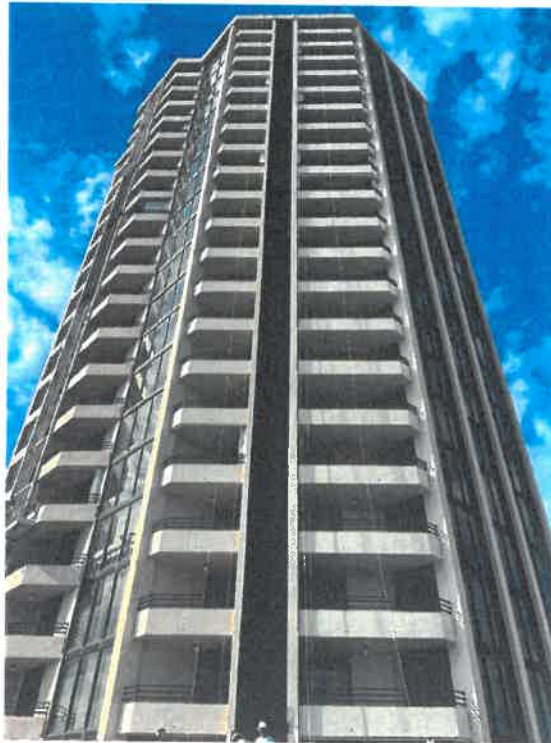
UEC was on-site to complete final punchout inspections at the 01 window wall and 02/03 balcony stack (see photos 1 and 2). The completed paint application at both the window wall and balcony stack was professional in appearance with no holidays observed. The deck coating at the balcony stack was evenly applied and continued up the cant bead as specified. The sliding glass doors and windows at each stack were construction cleaned and free of debris. The following items were brought to the Foreman's attention to be corrected at the balcony stack: Units 1803 and 1702 – excess paint on shutter, Unit 15A2 – touch up floor to wall joint at North corner. It was verified that the column on the window wall will be touched up during the final stage drop. The painting and deck coating remains to be completed at the 1<sup>st</sup> floor units of the balcony stack. The staging at both the window wall and balcony stack is approved to be moved after the items listed above are completed.

**Photograph #2: Completed scope of work at the 02/03 balcony stack**
