FIELD OBSERVATION REPORT PERMIT # BLDC-00620-2022

Report No. 27	Page 1 of 3
Project:	Oceans West One Condominium	Inspection For:	Building Repair and WP Project
Day/Date:	Tuesday, September 6, 2022	Job No.	20-1153
Location:	1 Oceans West Blvd. DBS, FL 32118	Engineer:	Christopher B. Longman, P.E.
Contractor:	SPEC Contractor Services	Project Foreman:	Alberto
Subcontractor:	None	Inspector:	Christopher B. Longman, P.E./ Andrew Holland
Weather:	82 Degrees @ 8:20 A.M. Sunny	Light Breeze	10% Chance of Rain
Workforce Total:	14		
Activities:	Identify damage 04/05 balcony stack, Gar Painting 03/04 stack and 01/06 stack	age concrete repair,	Concrete repair 02/03 stack,

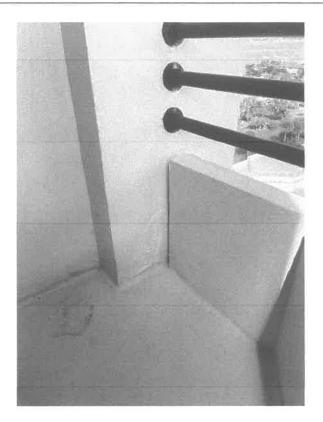
UEC ws on-site to identify stucco and concrete damage at the 04/05 balcony stack (see photos 1 and 2). The walls and slabs were acoustically sounded and visually inspected. Their was a small amount of concrete spalling damage marked with yellow paint for repair on the walls and topside of the balcony slabs.

Photograph #1: Damage identified at the 04 balcony stack

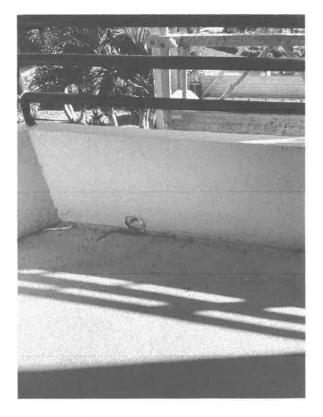
Photograph #2: Damage identified at the 04 balcony stack

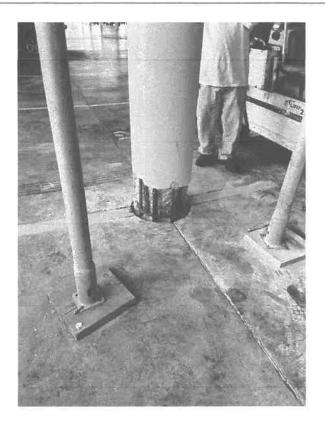
The Contractor requested an inspection for 3 column repairs located in the garage (see photo 3). The steel was cleaned and no supplemental steel is required for the repairs. Two of the repairs were requested to be firther excavated down to remove fractured concrete from the bottom of the columns. One of the column repairs is completed and approved to cast. A final inspection will be completed prior to casting the other two columns.

Photograph #3: Column repair requiring further excavations

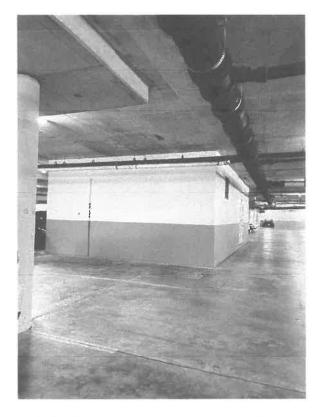
Concrete demo continues for repairs at the 02/03 balcony stack. Sanding and preparing louvers is in-progress at the 03/04 balcony stack and pressure washing for paint will begin once the louvers are completed. The paint application is in-progress at the 01/06 balcony stack. Post tension repairs in the garage are in-progress (see photo 4).

Photograph #4: Post tension work in-progress on the garage ceilings
