FIELD OBSERVATION REPORT PERMIT # BLDC-00620-2022

Report No. 58	Page 1 of 3
Project:	Oceans West One Condominium	Inspection For:	Building Repair and WP Project
Day/Date:	Friday, February 10, 2023	Job No.	20-1153
Location:	1 Oceans West Blvd. DBS, FL 32118	Engineer:	Christopher B. Longman, P.E.
Contractor:	SPEC Contractor Services	Project Foreman:	Alberto
Subcontractor:	None	Inspector:	Andrew Holland
Weather:	64 Degrees @ 1:10 P.M.	Sunny	Breezy 0% Chance of Rain
Workforce Total:	17		
Activities:	Tower A: Inspected repairs at the 01/02 stack, Concrete repair 02/03 balcony stack, Deck coating 05/06 stack

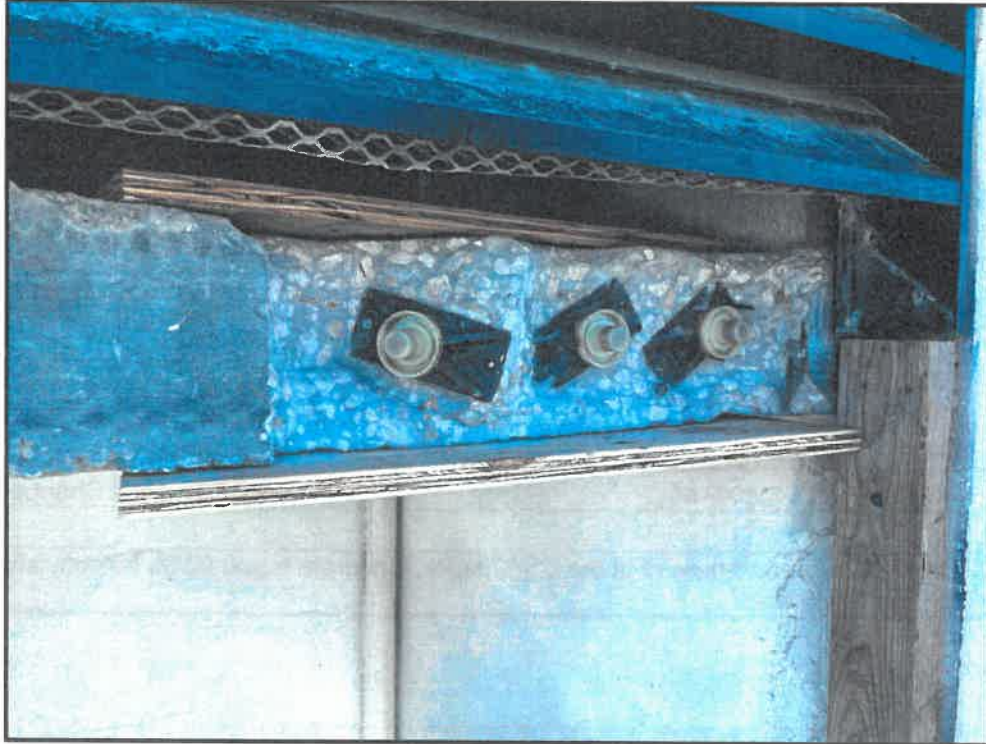
Tower A: The Contractor requested an inspection for the completed concrete repairs at the 01/02 balcony stack (see photos 1-3). It was verified that the existing steel was cleaned and the excavations continued to sound concrete and clean steel. The accepted repairs conformed to ICRI specifications and are approved to be cast. The following items were requested to be corrected and were not accepted: 19A2 – re-clean the structural steel, 17A1 – supplement existing reinforcing tie, 7A1 (inside A/C closet) – repair sheathing on post tension cables, A/C closet 1st floor – add #4 bar tied to existing steel, 1A1 – chase fractured concrete under sliding glass door.

Photograph #1: Accepted concrete repair at the 14th floor slab edge

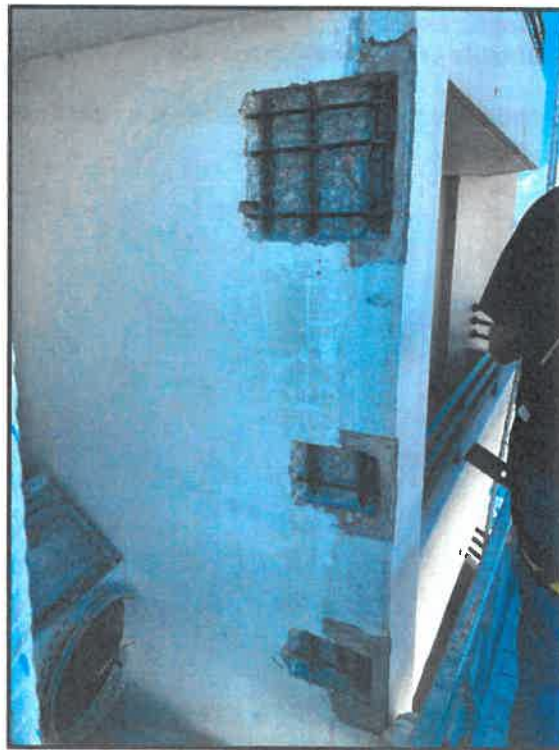
Photograph #2: Accepted wall repairs located at the interior of the A/C closet at the 5th floor

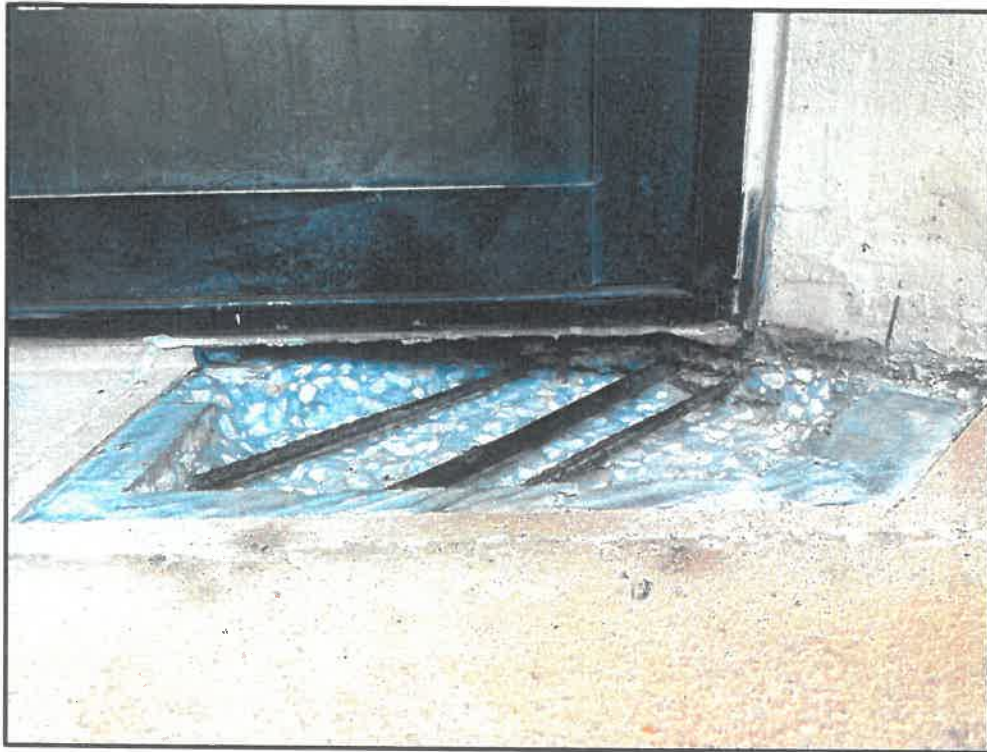
Photograph #3: Topside repair at the balcony of Unit 1A1 requested to be further excavated
