FIELD OBSERVATION REPORT PERMIT # BLDC-00620-2022

7	
		Report No. 54	Page 1 of 2
Project:	Oceans West One Condominium	Inspection For:	Building Repair and WP Project
Day/Date:	Thursday, January 26, 2023	Job No.	20-1153
Location:	1 Oceans West Blvd. DBS, FL 32118	Engineer:	Christopher B. Longman, P.E.
Contractor:	SPEC Contractor Services	Project Foreman:	
Subcontractor:	None	Inspector:	Christopher Longman P.E
Weather:	66 Degrees @ 1:00 P.M. Sunny	Calm win	
Workforce Total:	16		
Activities:	Tower A: 04/05 stack punch-out, 05/06 sta staging	ick stucco, 01/02 sta	ack concrete repair, 02/03 stack

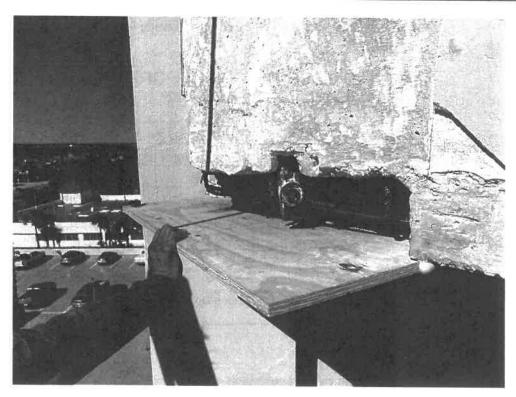
<u>Tower A</u>: Contractor requested an inspection for the installation of a new post tensioned cable anchor and reinforcing steel at the balcony slab edge of Unit 7A6 (05/06 stack). The cable was previously identified within a slab repair and the anchor was not present. A new anchor was installed with new backing reinforcement. The Contractor was directed to install a pocket former before casting the repair. The repair was approved to be cast back.

Photograph #1: Post tensioned cable anchor installed

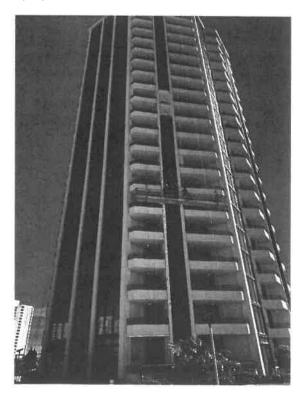
All stucco is re-applied at the 05/06 balcony stack and the Contractor will prepare to start painting. The deck coating process is complete at the 04/05 balcony stack and punch-out work is in-progress. Concrete repairs are in-progress at the 01/02 balcony stack. Staging is in the process of being installed at the 02/03 balcony stack.

Photograph #2: Concrete repair in-progress at the 01/02 balcony stack
