FIELD OBSERVATION REPORT PERMIT # BLDC-00620-2022

| | | Report No. 37 | Page 1 of 2 |
| Project: | Oceans West One Condominium | Inspection For: | Building Repair and WP Project |
| Day/Date: | Friday, November 4, 2022 | Job No. | 20-1153 |

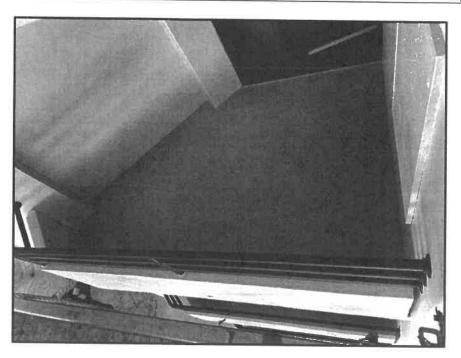
Tower B: The Contractor requested a final punchout inspection for the completed painting and waterproofing at the 02/03 balcony stack. The painting application was professional in appearance with no holidays observed. Deck coating at the 02/03 balcony was evenly applied and continued up the cant bead as specified. The following items were brought to the Foremans attention to be corrected at the 02/03 balcony stack: Unit 21B3-touch up paint on ceiling and clean shutters, 10B2-clean shutters, 7B2 clean paint off electrical outlet, 21B2-repair deck coating at cant bead, 20B3, 20B2, 12B2,10B2, 9B2, 8B3, 7B2, 7B3, 4B2-clean paint off light fixture. The deck coating application at the 1st floor and the paint application at the South column are left to be completed at the 02/03 balcony stack and it was requested for the AC vents at the lower 3 elevations be touched up.

Photograph #1: Completed waterproofing and painting at a balcony on the 03 balcony stack

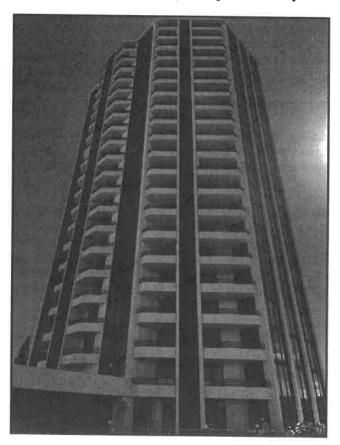
Photograph #2: Completed scope of work at the 02/03 balcony stack
