FIELD OBSERVATION REPORT PERMIT # BLDC-00620-2022

18 Page 1 of 2
For: Building Repair and WP Project
20-1153
Christopher B. Longman, P.E.
eman: Alberto
Christopher B. Longman, P.E.
vinds 0% Chance of Rain
ch-out 05/06

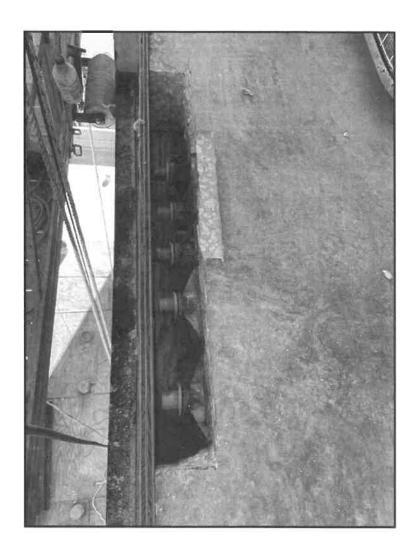
The Contractor requested an inspection for the completed concrete repairs located in the A/C closets at the 03/04 stack. The repairs on floors 11 through 2 were ready for inspection. UEC verified the repairs were excavated to sound concrete and conformed to ICRI standards for excavation geometry, surface profile and circumference around the reinforcing steel. The existing steel was cleaned and supplemental steel was installed as directed. Several repairs inspected today involved post tension cable anchor heads. The anchor heads were cleaned and did not require destressing of the cables. Each post tension cable anchor head had a grease cap installed (see photo 1). The repairs were accepted and approved to be cast.

Photograph #1: Accepted concrete repair with post tension cable anchor head caps at the 03/04 stacks AC closets
