FIELD OBSERVATION REPORT

Report No. 3	Page 1 of 3
Project:	Oceans West One Condominium	Inspection For:	Building Repair and WP Project
Day/Date:	Friday, May 13, 2022	Job No.	20-1153
Location:	1 Oceans West Blvd. DBS, FL 32118	Engineer:	Christopher B. Longman, P.E.
Contractor:	SPEC Contractor Services	Project Foreman:	Alberto
Subcontractor:	None	Inspector:	Christopher B. Longman, P.E.
Weather:	80 Degrees @ 12:45 P.M.	Partly Sunny	Light Breeze 30% Chance of Rain
Workforce Total:	7		
Activities:	Concrete repair 05/06 and 01/02 stacks, Engineering inspection 06/01 stack

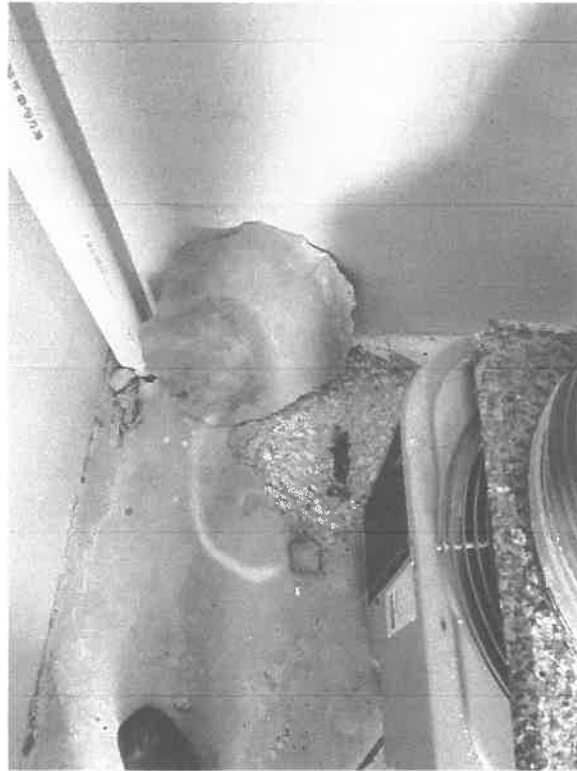
Photograph #1: Topside damage requiring A/C to be re-located

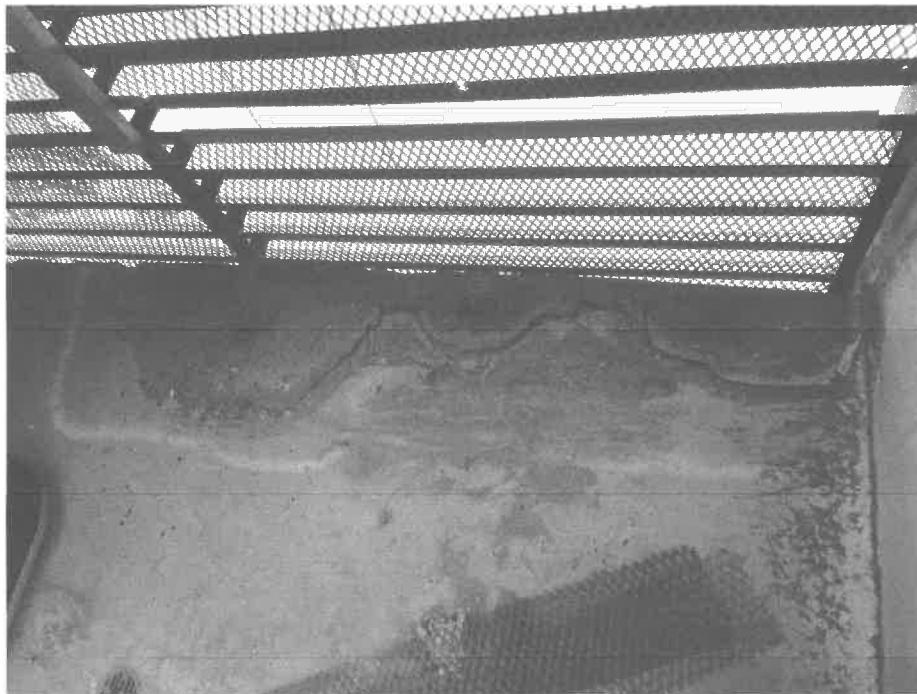
Photograph #2: Typical Slab edge damage

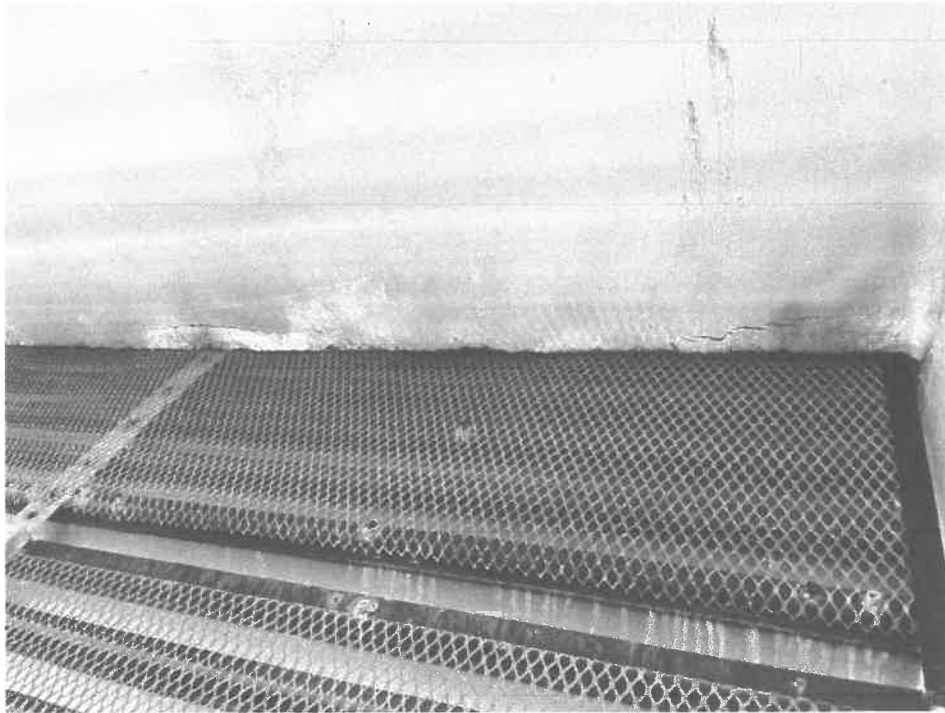
Photograph #3: Ceiling slab edge damage

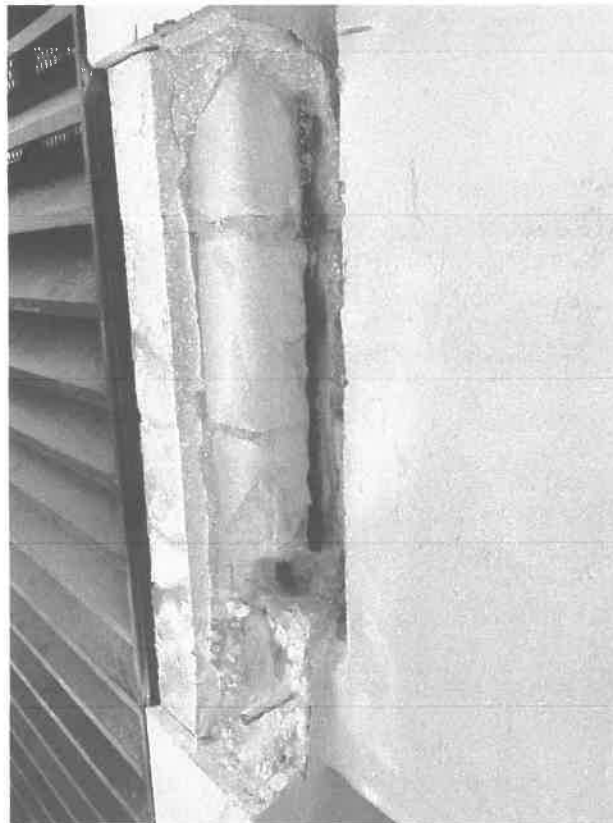
Photograph #4: In-progress repair excavation 01/06 stack wall
