## FIELD OBSERVATION REPORT PERMIT # BLDC-00620-2022

Report No. 11	Page 1 of 2
Project:	Oceans West One Condominium	Inspection For:	Building Repair and WP Project
Day/Date:	Thursday, June 23, 2022	Job No.	20-1153
Location:	1 Oceans West Blvd. DBS, FL 32118	Engineer:	Christopher B. Longman, P.E.
Contractor:	SPEC Contractor Services	Project Foreman:	Alberto
Subcontractor:	None	Inspector:	Christopher B. Longman, P.E.
Weather:	84 Degrees @ 10:35 A.M.	Sunny	Breezy winds 30% Chance of Rain
Workforce Total:	13		
Activities:	Pressure washing 05/06, Concrete repair 06/01 and Painting 01/02 balcony stacks

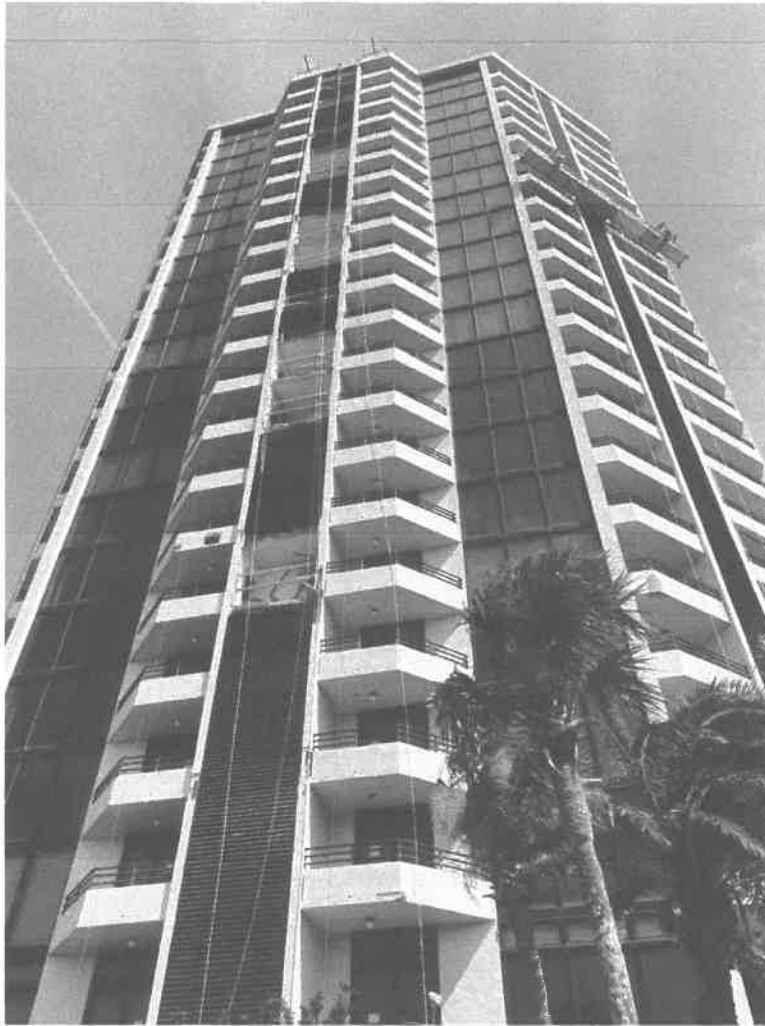
**Photograph #1: Restoration work in-progress at the 05/06, 06/01 and 01/02 balcony stacks**
