# UNITED ENGINEERING CONSULTANTS, INC.

## FIELD OBSERVATION REPORT PERMIT # BLDC-00620-2022

Report No. 8	Page 1 of 2
Project:	Oceans West One Condominium	Inspection For:	Building Repair and WP Project
Day/Date:	Tuesday, June 14, 2022	Job No.	20-1153
Location:	1 Oceans West Blvd. DBS, FL 32118	Engineer:	Christopher B. Longman, P.E.
Contractor:	SPEC Contractor Services	Project Foreman:	Alberto
Subcontractor:	None	Inspector:	Christopher B. Longman, P.E.
Weather:	80 Degrees @ 9:10 A.M.	Sunny	Light winds 20% Chance of Rain
Workforce Total:	13		
Activities:	Concrete repair 05/06, 06/01 and 01/02 balcony stacks

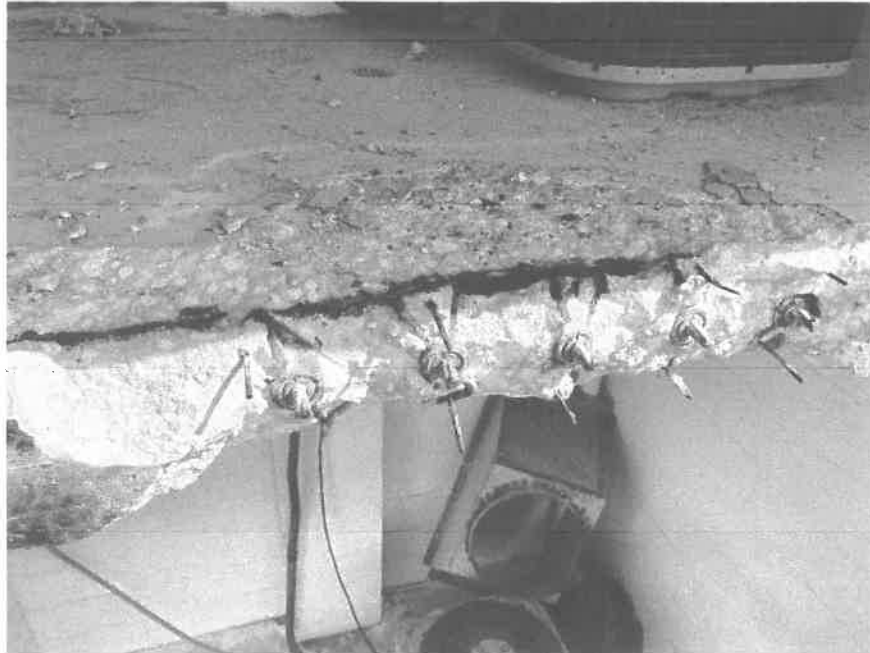
The aluminium louvers were removed from the face of several AC closets at the 01/06 stacks, where spalling was identified at the slab edge behind the louver. The Contractor partially excavated to remove spalled concrete from the front side of post tension cable anchors located along the slab edge. UEC inspected the in-progress repairs to identify where structural damage continued behind the anchor and required the tendon to be temporarily de-tensioned. The following was noted at the AC closet for the 01/06 stacks:

- Floor 19: 5 cables requiring de-tensioning
- Floor 14: 5 cables requiring de-tensioning
- Floor 12: 5 cables requiring de-tensioning
- Floor 11: 5 cables requiring de-tensioning
- Floor 10: 5 cables requiring de-tensioning
- Floor 9: 2-5 cables requiring de-tensioning

**Photograph #1: Typical slab edge at 01/06 stack AC closet slab edge designated for tendon de-tensioning**
