UNITED ENGINEERING CONSULTANTS, INC.

FIELD OBSERVATION REPORT PERMIT # BLDC-00620-2022

| Project: | Oceans West One Condominium | Inspection For: | Building Repair and WP Project |
| Day/Date: | Thursday, July 28, 2022 | Job No. | 20-1153 |

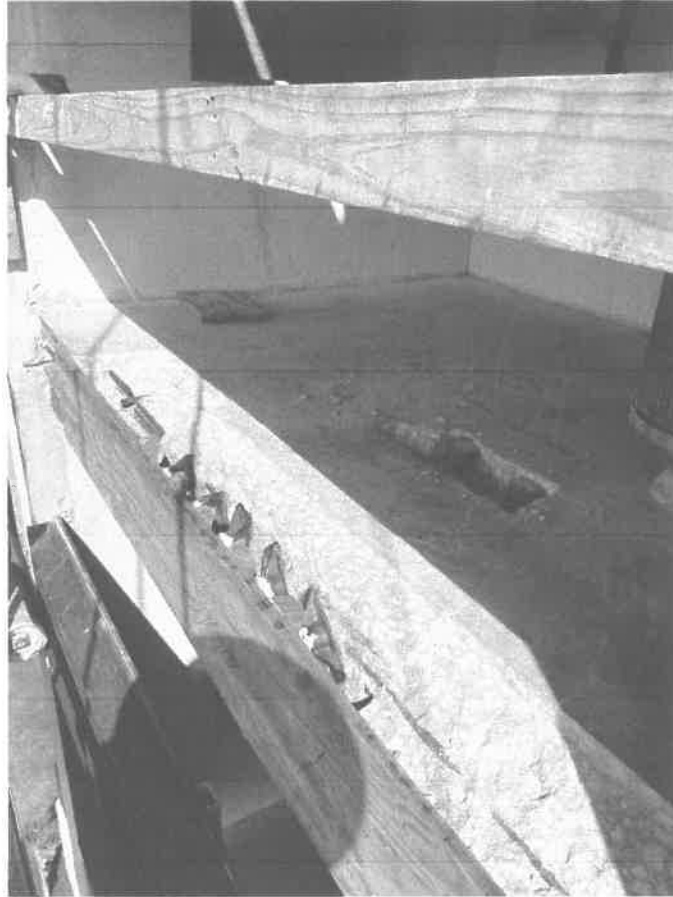
Concrete repairs at the slab edges of the 01/06 stack AC closets were inspected. The edge repairs with post tension cable anchors that did not require de-stressing were formed and prepared for re-casting. The Contractor properly detailed the excavations. Grease caps were installed to the tendon tail and anchor plate for protection. Repairs at floors 19, 12, 11, 10 and 9 were inspected and approved to be cast back.

Photograph #1: Typical slab edge repair at the 01/06 stack
