UNITED ENGINEERING CONSULTANTS, INC.

FIELD OBSERVATION REPORT

Report No. 9	Page 1 of 2
Project:	Oceans West One Condominium	Inspection For:	Building Repair and WP Project
Day/Date:	Monday, June 20, 2022	Job No.	20-1153
Location:	1 Oceans West Blvd. DBS, FL 32118	Engineer:	Christopher B. Longman, P.E.
Contractor:	SPEC Contractor Services	Project Foreman:	Alberto
Subcontractor:	None	Inspector:	Christopher B. Longman, P.E.
Weather:	84 Degrees @ 12:40 P.M.	Sunny	Breezy winds 10% Chance of Rain
Workforce Total:	13		
Activities:	Concrete repair 05/06, 06/01 and 01/02 balcony stacks

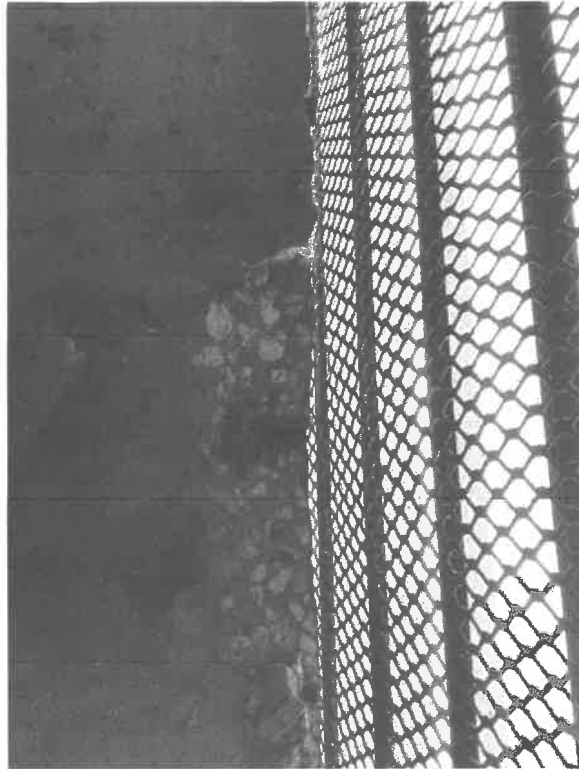
- 9th floor: Topside spall under AC unit
- 8th floor: Topside spall under AC unit
- 7th floor: Cracked edge (PT work possible)
- 6th floor: Topside spall at edge (PT work possible)
- 4th floor: Topside spall unit AC unit
- 3rd floor: Topside spall under AC unit and exposed PT head at slab edge

Photograph #1: Exposed PT anchor at 3rd floor slab edge
