FIELD OBSERVATION REPORT PERMIT # BLDC-00620-2022

Report No. 39	Page 1 of 2
Project:	Oceans West One Condominium	Inspection For:	Building Repair and WP Project
Day/Date:	Wednesday, November 16, 2022	Job No.	20-1153
Location:	1 Oceans West Blvd. DBS, FL 32118	Engineer:	Christopher B. Longman, P.E.
Contractor:	SPEC Contractor Services	Project Foreman:	Alberto
Subcontractor:	None	Inspector:	Andrew Holland
Weather:	73 Degrees @ 7:55 A.M.	Cloudy	Light Breeze 40% Chance of Rain
Workforce Total:	19		
Activities:	Final punchout 05 window wall of Tower A

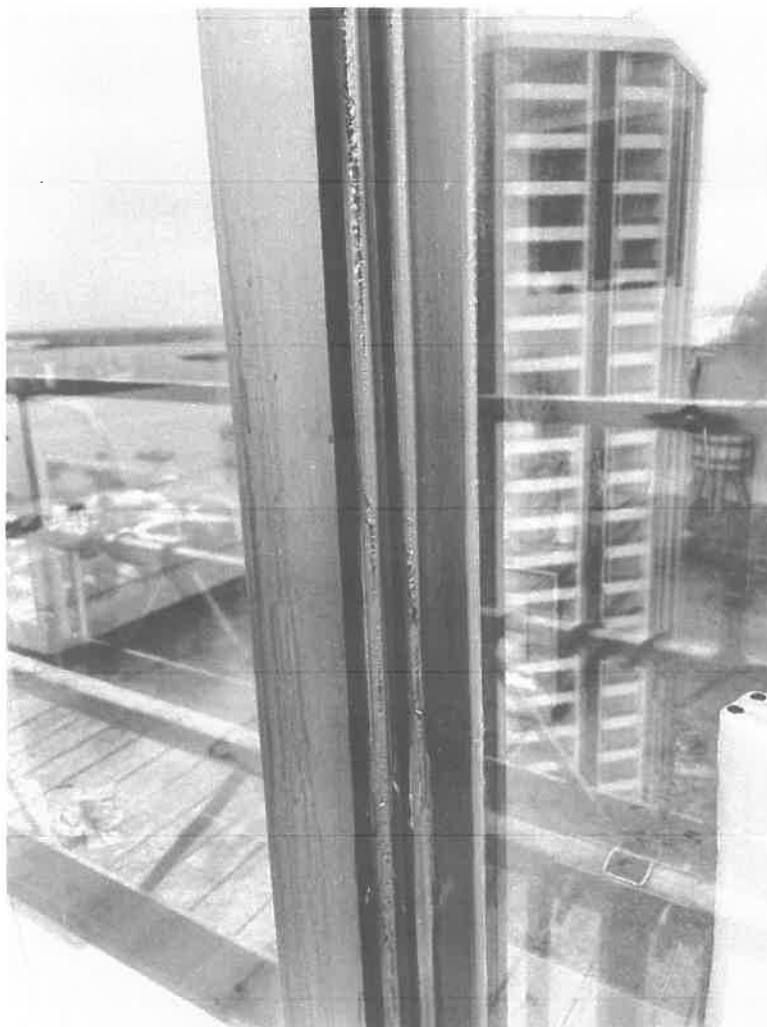
Deteriorated window sealants were observed at the 05 stack windows and were requested to be repaired. The metal-to-metal sealants around the aluminum window frames appear to be degrading and some the sealant came loose during pressure washing. SPEC will replace the failed areas as a temporary repair and the Engineer will discuss the condition with the Owner.

Photograph #1: Degraded sealants observed at the 05 window wall of Tower A
