FIELD OBSERVATION REPORT PERMIT # BLDC-00620-2022

Report No. 57	Page 1 of 2
Project:	Oceans West One Condominium	Inspection For:	Building Repair and WP Project
Day/Date:	Monday, February 6, 2023	Job No.	20-1153
Location:	1 Oceans West Blvd. DBS, FL 32118	Engineer:	Christopher B. Longman, P.E.
Contractor:	SPEC Contractor Services	Project Foreman:	Alberto
Subcontractor:	None	Inspector:	Andrew Holland
Weather:	64 Degrees @ 1:10 P.M. Sunny	Breezy	0% Chance of Rain
Workforce Total:	17		
Activities:	Tower A: Final punchout inspection, Concubeginning at the 05/06 stack	rete demo 02/03 and	d 01/02 stacks, Primer application

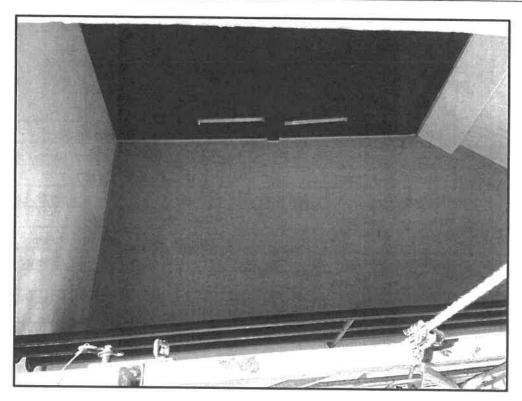
Tower A: UEC was on-site to complete a final punchout inspection for the completed painting, waterproofing and general cleanup at the 04/05 balcony stack (see photos 1 and 2). The paint application was professional in appearance with no holidays observed and a neat cut-in. The deck coating was evenly applied and continued up the cant bead as specified. The sliding glass doors and guardrails were construction cleaned and free of debris. The following was brought to the Foremans attention to be corrected: Unit 12A4 - touch up on exterior of knee wall, column at 10th floor touch up, 5A5 install bracket for louver at interior of A/C closet. Painting and deck coating remains to be completed for the 1st floor units. The swing stages are approved to be moved after the items listed above are corrected.

Photograph #1: Completed deck coating at a balcony on the 04 stack

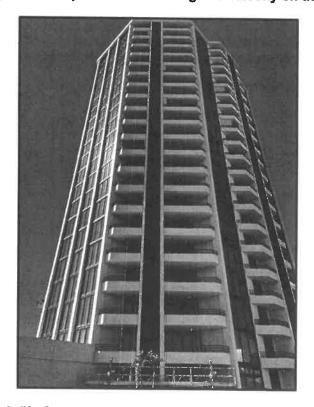
Photograph #2: Completed scope of work at the 04/05 balcony stack

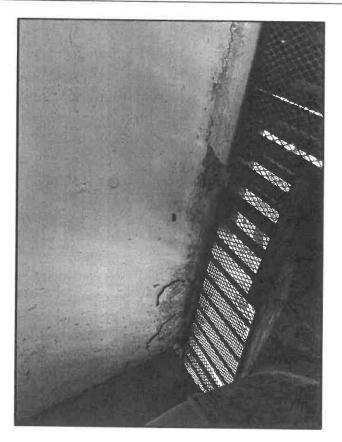
Photograph #3: Damage identified at the interior of an A/C closet

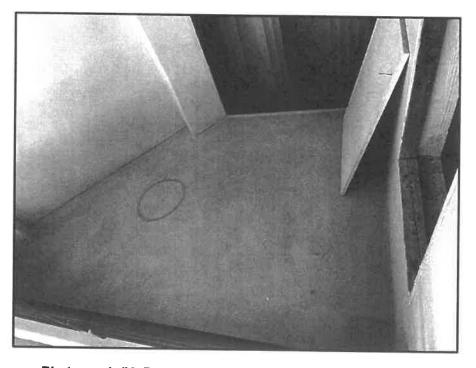
Photograph #4: Damage identified at the balcony of Unit 3A3
