FIELD OBSERVATION REPORT PERMIT # BLDC-00620-2022

Report No. 30 Page 1 of 2

Project:	Oceans West One Condominium	Inspection For:	Building Repair and WP Project
Day/Date:	Thursday, September 23, 2022	Job No.	20-1153
Location:	1 Oceans West Blvd. DBS, FL 32118	Engineer:	Christopher B. Longman, P.E.
Contractor:	SPEC Contractor Services	Project Foreman:	Alberto
Subcontractor:	None	Inspector:	Christopher B. Longman, P.E.
Weather:	80 Degrees @ 1:30 P.M.	Sunny	Breezy winds 20% Chance of Rain
Workforce Total:	16		
Activities:	Concrete repair 04/05 balcony stack, Painting 02/03 stack, Deck coating 01/06 stack, Deck coating prep 03/04 stack

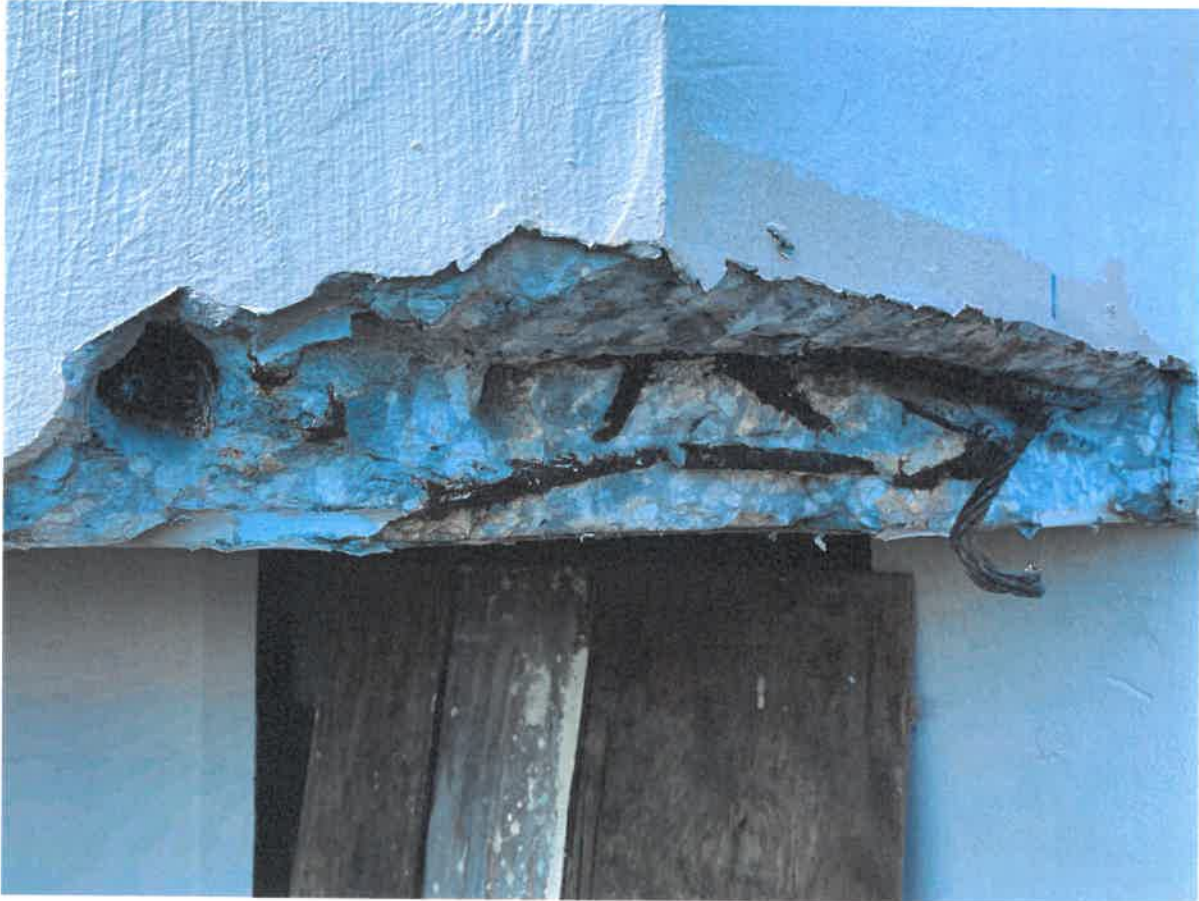
The post tension cable subcontractor returned to repair the broken cable at the balcony edge of Unit 2B5. The cable runs from the slab edge at Unit 2B5 livingroom balcony to the slab edge of the bedroom balcony. UEC met with the Subcontractor to discuss options for repairing the broken cable. It was agreed that the rebar corrosion will require the second cable running parallel to the broken cable to be detensioned. A perpendicular cable in the area will need a lock-off installed as a safety precaution. A new cable will be threaded through to replace the broken cable and two new anchors will be installed at the corner of the living room slab. After the concrete is re-cast and adequately cured, the cables will be re-tensioned from the bedroom balcony slab edge.

Photograph #1: Exposed broken post tension cable at Unit 2B5 balcony
