## FIELD OBSERVATION REPORT PERMIT # BLDC-00620-2022

Report No. 52	Page 1 of 3
Project:	Oceans West One Condominium	Inspection For:	Building Repair and WP Project
Day/Date:	Thursday, January 19, 2022	Job No.	20-1153
Location:	1 Oceans West Blvd. DBS, FL 32118	Engineer:	Christopher B. Longman, P.E.
Contractor:	SPEC Contractor Services	Project Foreman:	Alberto
Subcontractor:	None	Inspector:	Andrew Holland
Weather:	64 Degrees @ 8:25 A.M.	Sunny	Breezy 0% Chance of Rain
Workforce Total:	17		
Activities:	Tower A: Identified damage 01/02 stack, Contractor punchout 01/06 stack, Pressure washing 04/05 stack, Post tension repair in garage

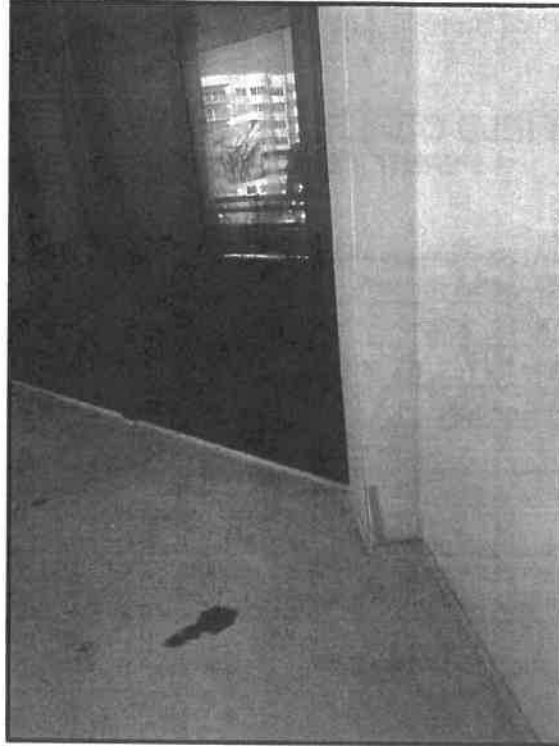
**Tower A:** UEC was on-site to identify concrete and stucco damage at the 01/02 balcony stack (see photos 1 - 3). The walls, slabs and interior of the A/C closets were acoustically sounded and visually inspected at each elevation. Damaged areas were marked with orange paint for repair.

**Photograph #1: Damage identified at the balcony of Unit 17A1**

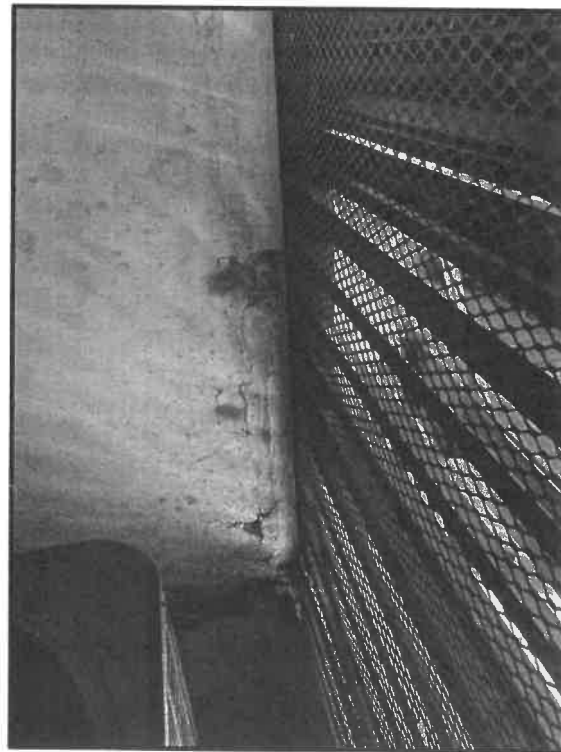
**Photograph #2: Damage identified in the A/C closet designated for Unit 12A2**

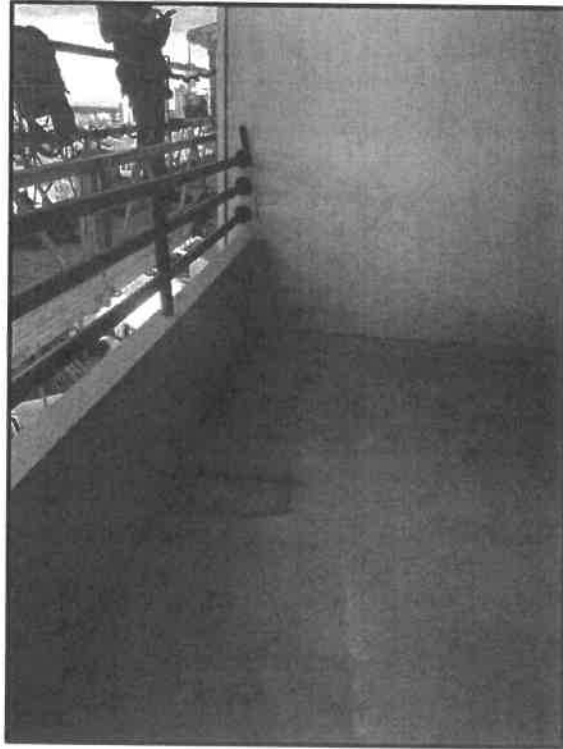
**Photograph #3: Damage identified at the balcony of Unit 6A1**
