UNITED ENGINEERING CONSULTANTS, INC.

FIELD OBSERVATION REPORT PERMIT # BLDC-00620-2022

Report No. 6	Page 1 of 2
Project:	Oceans West One Condominium	Inspection For:	Building Repair and WP Project
Day/Date:	Friday, June 3, 2022	Job No.	20-1153
Location:	1 Oceans West Blvd. DBS, FL 32118	Engineer:	Christopher B. Longman, P.E.
Contractor:	SPEC Contractor Services	Project Foreman:	Alberto
Subcontractor:	None	Inspector:	Christopher B. Longman, P.E.
Weather:	80 Degrees @ 9:16 A.M.	Sunny	Calm Breeze 40% Chance of Rain
Workforce Total:	7		
Activities:	Concrete repair 05/06, 06/01 and 01/02 balcony stacks

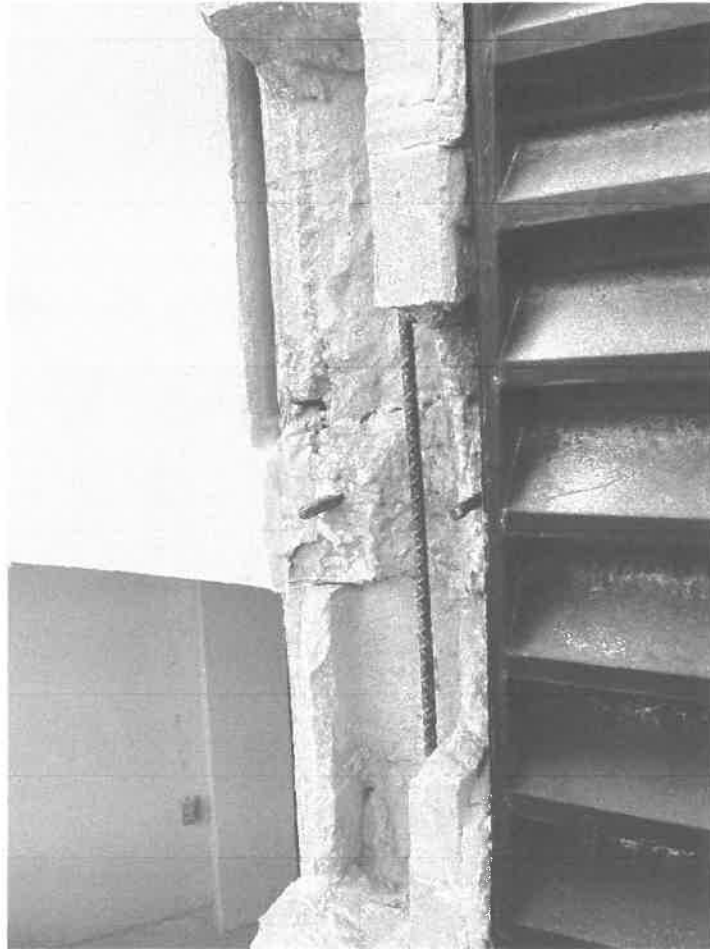
A final inspection was completed at the 01/02 stack for additional repairs at the nose of the CMU wall adjacent to the louver vent at floors 4th through 8th. New # 5 vertical reinforcement was installed by epoxy dowelling and lapping as directed. The existing steel was cleaned adequately. The repairs conformed to ICRI standards for excavation geometry, surface profile and circumference around the reinforcing steel. The accepted repairs were approved to be cast.

Photograph #1: Accepted wall nose repair at the 02/01 balcony stack
