UNITED ENGINEERING CONSULTANTS, INC.

FIELD OBSERVATION REPORT PERMIT # BLDC-00620-2022

Report No. 55	Page 1 of 3
Project:	Oceans West One Condominium	Inspection For:	Building Repair and WP Project
Day/Date:	Friday, January 27, 2023	Job No.	20-1153
Location:	1 Oceans West Blvd. DBS, FL 32118	Engineer:	Christopher B. Longman, P.E.
Contractor:	SPEC Contractor Services	Project Foreman:	Alberto
Subcontractor:	None	Inspector:	Andrew Holland
Weather:	53 Degrees @ 9:25 A.M.	Sunny	Breezy
			0% Chance of Rain
Workforce Total:	17		
Activities:	Tower A: Identified damage 02/03 balcony stack, Louver removal complete 01/02 balcony stack, Paint touch-up 04/05 stack, Sealant application 05/06 stack

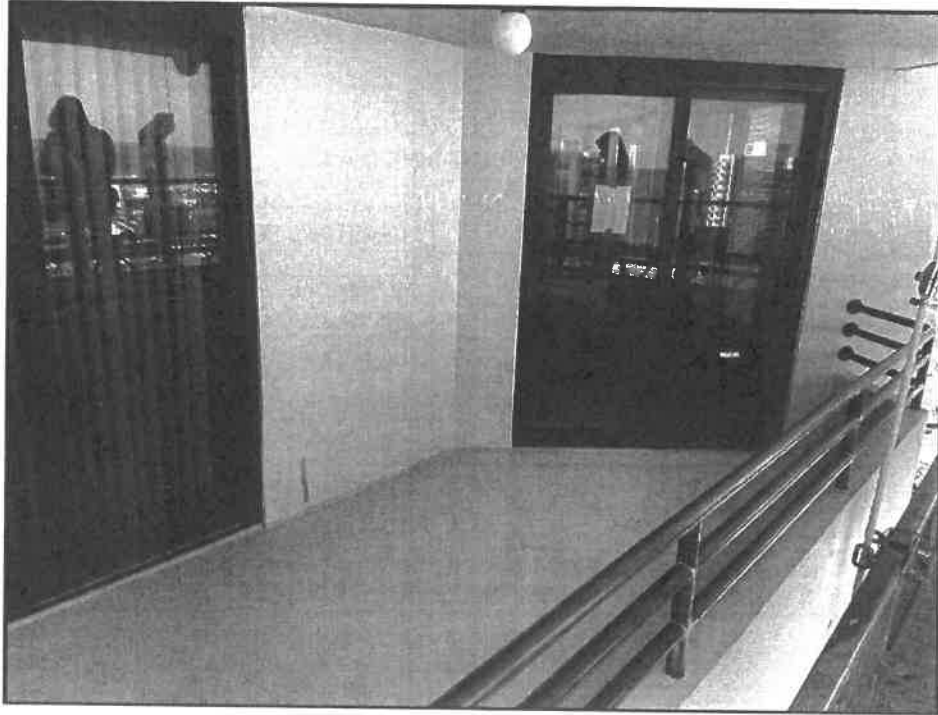
Tower A: The Contractor has installed a swing stage at the 02/03 balcony stack. UEC was on-site to identify areas of concrete and stucco damage for the Contractor(see photos 1 – 4). Each balcony was visited along with the interior of the A/C closets. The walls, slabs and columns were acoustically sounded and visually inspected. Damaged areas were marked with orange paint for repair.

Photograph #1: Damage identified at the balcony of Unit 21A2

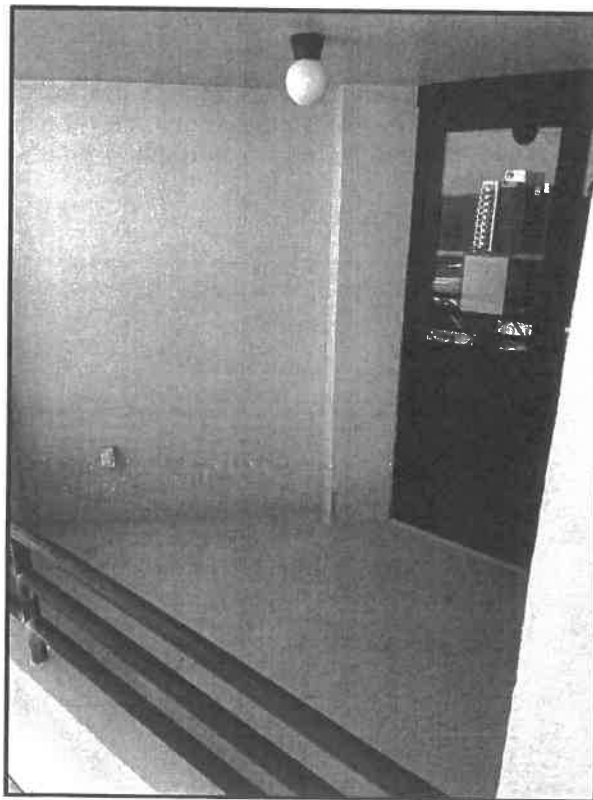
Photograph #2: Damage identified at the balcony of Unit 21A3

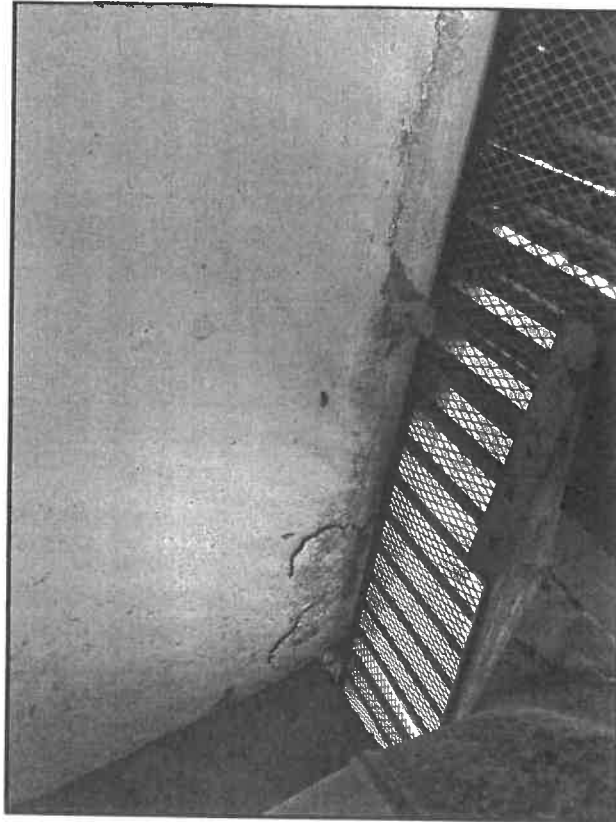
Photograph #3: Damage identified at the interior of an A/C closet

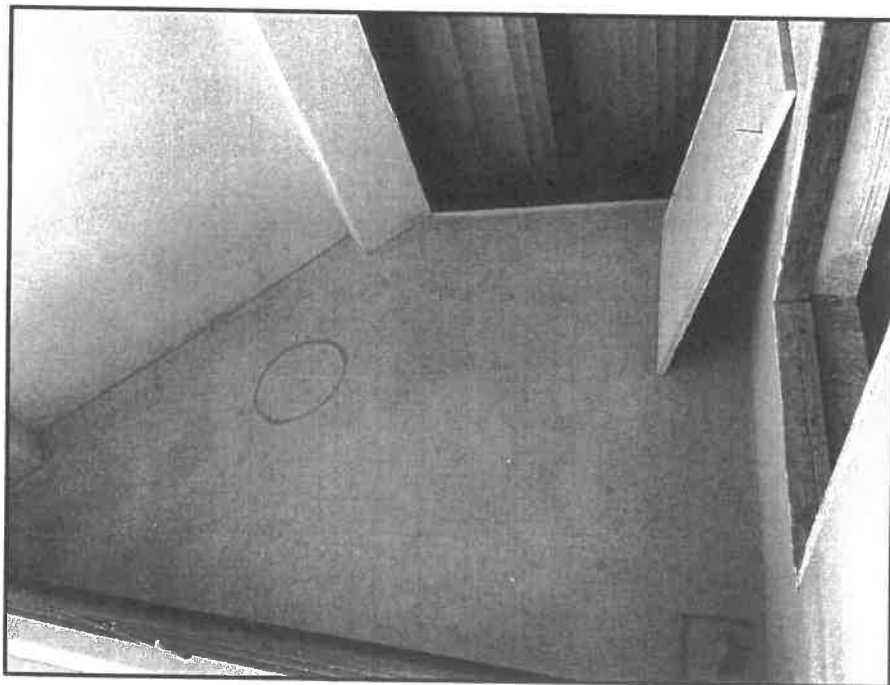
Photograph #4: Damage identified at the balcony of Unit 3A3
