FIELD OBSERVATION REPORT PERMIT # BLDC-00620-2022

Report No. 33	Page 1 of 2
Project:	Oceans West One Condominium	Inspection For:	Building Repair and WP Project
Day/Date:	Wednesday, October 19, 2022	Job No.	20-1153
Location:	1 Oceans West Blvd. DBS, FL 32118	Engineer:	Christopher B. Longman, P.E.
Contractor:	SPEC Contractor Services	Project Foreman:	
Subcontractor:	None	Inspector:	Christopher B. Longman, P.E.
Weather:	54 Degrees @ 9:20 A.M. Partly C	loudy Light Br	eeze 20% Chance of Rain
Workforce Total:	16		
Activities:	Post tension repairs Unit 2B5/2B4, Garag stack	ge post tension repai	rs, Painting 03/04 stack and 04/05

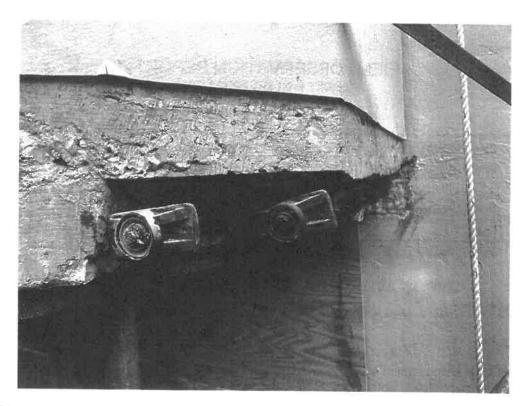
The Contractor requested an inspection for the in-progress post tension concrete repair on the balcony of Unit 2B5 (see photos 1 and 2). The East balcony corner of the slab underneath the knee wall has been excavated. There was 2 broken post tension cables that have been replaced with new cables from the slab edge at 2B5 to the slab edge at 2B4. Further excavations are required at Unit 2B5 to remove fractured concrete and chase the corroded steel. UEC provided direction for supplementing the steel by epoxy dowelling 2 new vertical hook bars and an edge bar. It was also requested for additional backer bars to be installed behind the post tension anchor heads. A final inspection will be completed after the steel is added and the excavations are complete.

Photograph #1: In-progress post tension concrete repair at the balcony of Unit 2B5

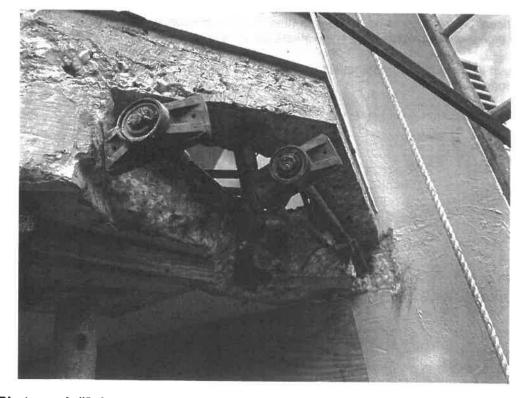
Photograph #2: In-progress post tension concrete repair at the balcony of Unit 2B5
