## FIELD OBSERVATION REPORT PERMIT # BLDC-00620-2022

Report No. 76	Page 1 of 2
Project:	Oceans West One Condominium	Inspection For:	Building Repair and WP Project
Day/Date:	Friday, June 2, 2023	Job No.	20-1153
Location:	1 Oceans West Blvd. DBS, FL 32118	Engineer:	Christopher B. Longman, P.E.
Contractor:	SPEC Contractor Services	Project Foreman:	Alberto
Subcontractor:	None	Inspector:	Christopher B. Longman, P.E. Andrew Holland
Weather:	79 Degrees @ 10:15 A.M.	Sunny	Light Breeze 20% Chance of Rain
Workforce Total:	5		
Activities:	Tower A: Re-installing A/C Closet Louvers, Parking Garage: Installing New Post tension Cables

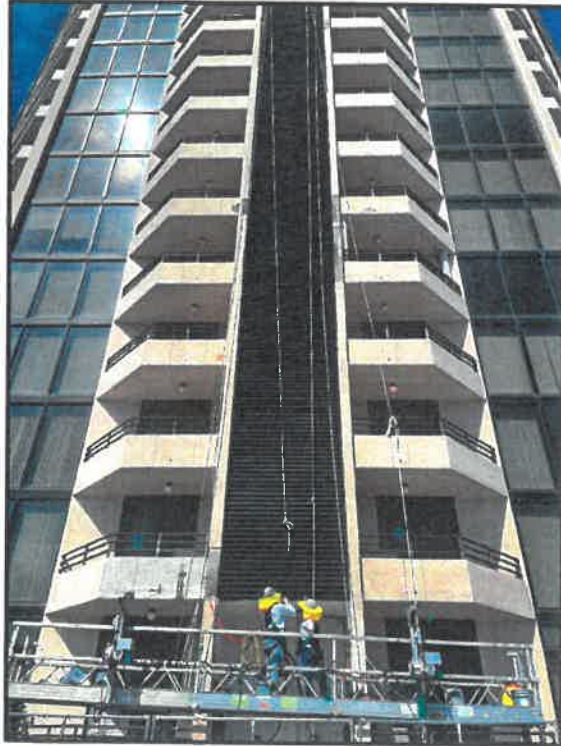
UEC visited the jobsite to review the in-progress activities with the Foreman. Re-installing the louvers at the A/C closets is in-progress at the 03/04 balcony stack (see photos 1 and 2). It was verified that new 1/4" stainless steel masonry fasteners are being installed at all pre-existing attachment points and achieving a minimum of 2 inch embedment depth.

**Photograph #1: A/C louver re-installation in-progress**

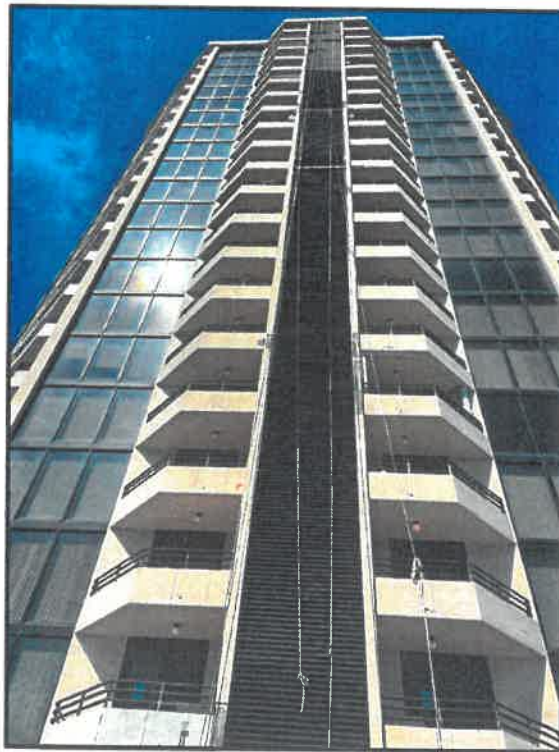
**Photograph #2: A/C louver re-installation in-progress**
